COMMUNITIES AND ENVIRONMENT OVERVIEW AND SCRUTINY PANEL

6. Flood Recovery in Doncaster – Partnership Update (*Pages 9 - 234*)
7. Overview and Scrutiny Work Plan and the Council's Forward Plan of Key Decisions. (*Pages 235 - 248*)

SOUTH BENTLEY NOVEMBER 2019 FLOODS

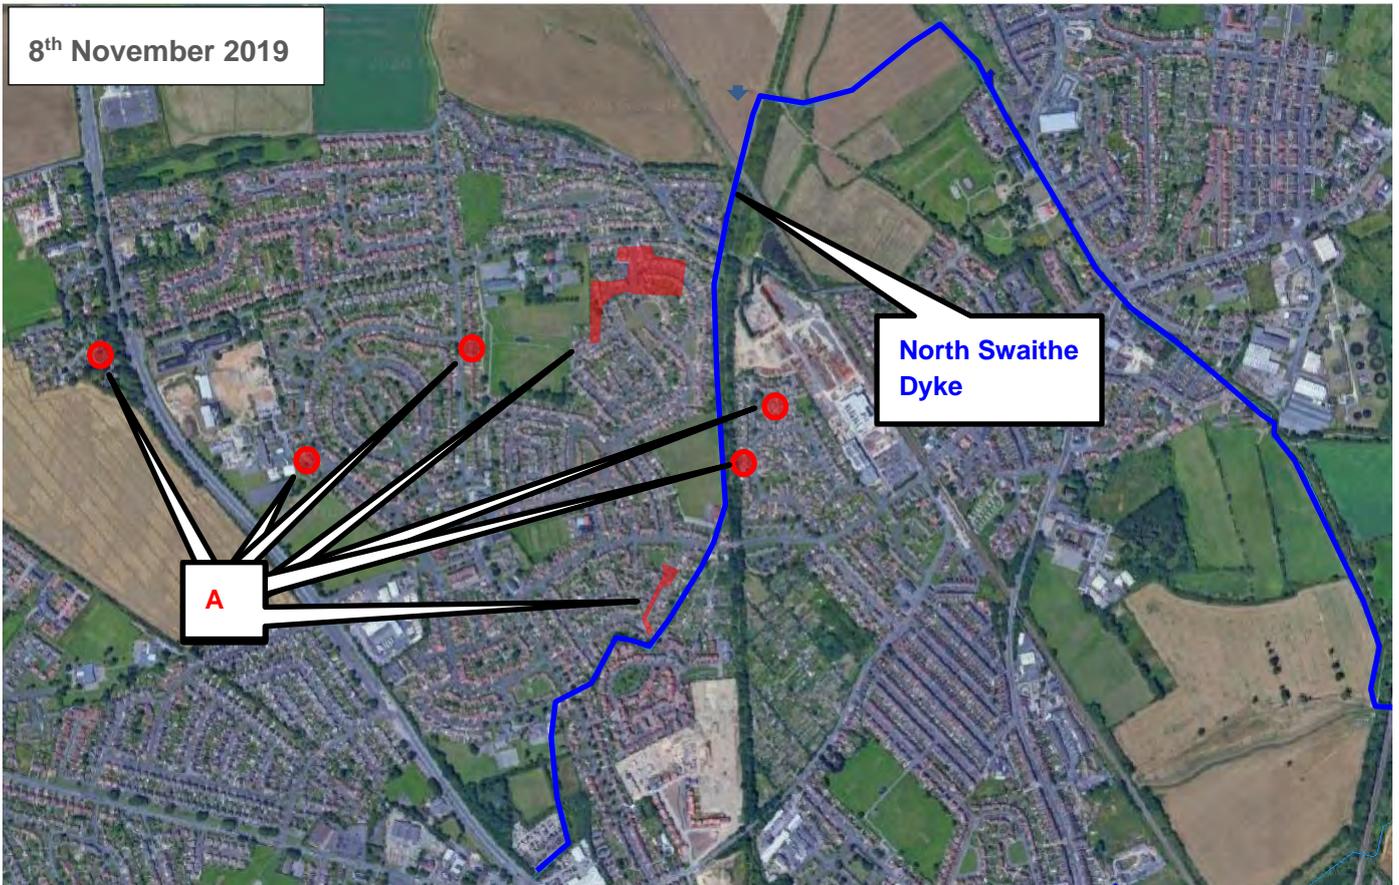
FIGURE 16: GOOGLE MAPS SCREENSHOT SHOWING FLOOD FLOW ROUTES AND EXTENT

Within the Scawthorpe ward 56 properties are recorded as having been flooded by Doncaster Council in November 2019.

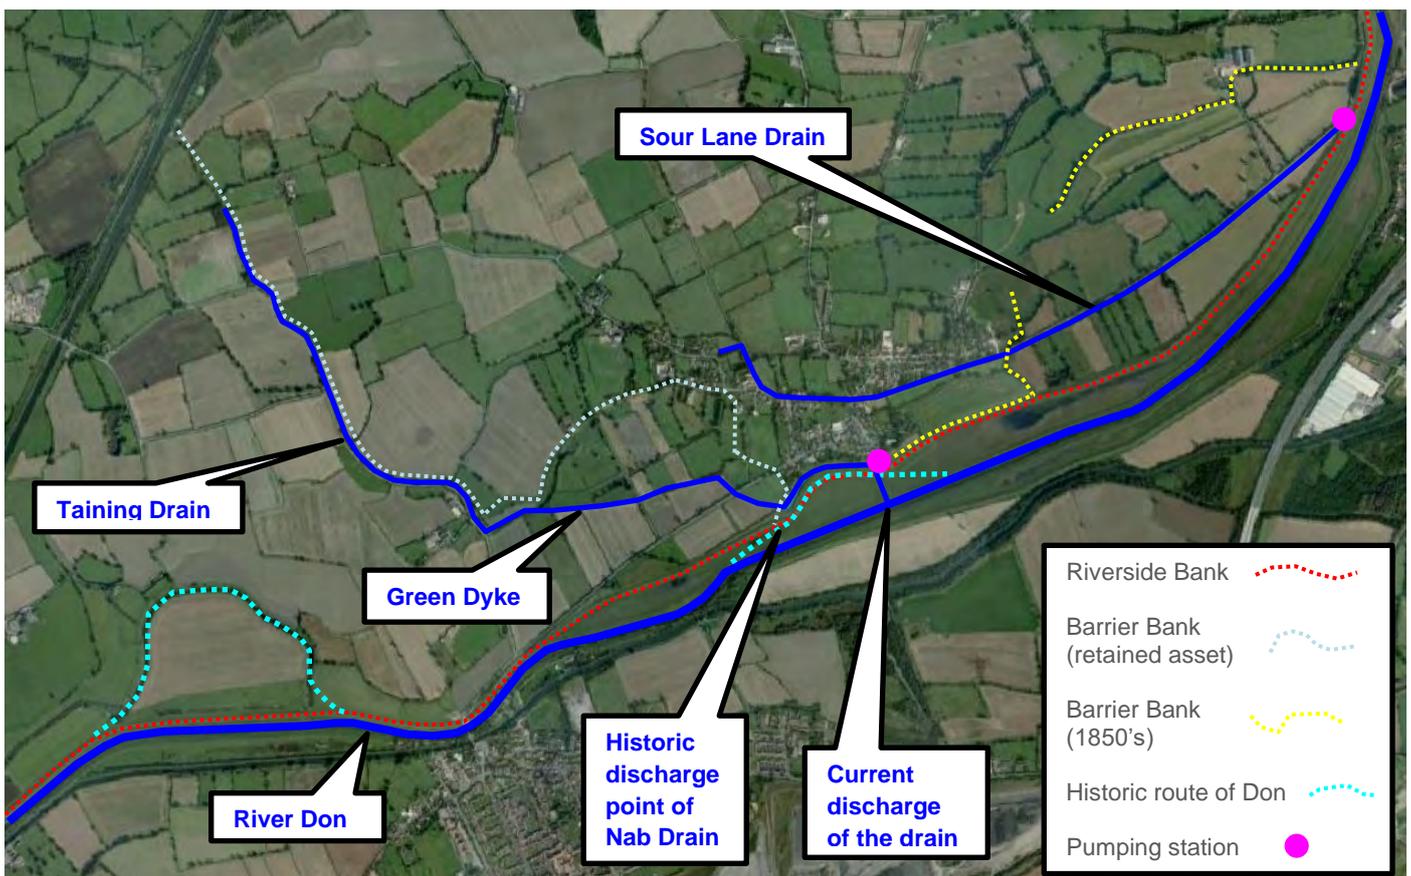
FIGURE 17: SCREENSHOT FROM GOOGLE MAPS SHOWING THE APPROXIMATE LOCATION OF KEY FEATURES AROUND FISHLAKE

Most of Fishlake is designated as Flood Zone 3 on the Environment Agency's Flood Map for Planning which is described as land assessed as having a 1 in 100 or greater annual probability of river flooding (>1%), or a 1 in 200 or greater annual probability of flooding from the sea (>0.5%) in any year. Significant areas are also designated as benefitting from flood defences, which is defined as those areas that would benefit from the presence of defences in a 1 percent fluvial / 0.5 percent tidal flood event. Both the Riverside Bank and Barrier Bank are however designated with a 75 year (1.33%) standard of protection on asset data provided for this report. The Environment Agency's Flood Map which gives a generalised view of the long-term flood risk for an area in England shows large parts of Fishlake as being at medium flood risk from rivers (a chance of flooding of between 1% and 3.3% AEP) and low risk (a chance of flooding of between 0.1% and 1% AEP). These designations take into account the effect of flood defences.

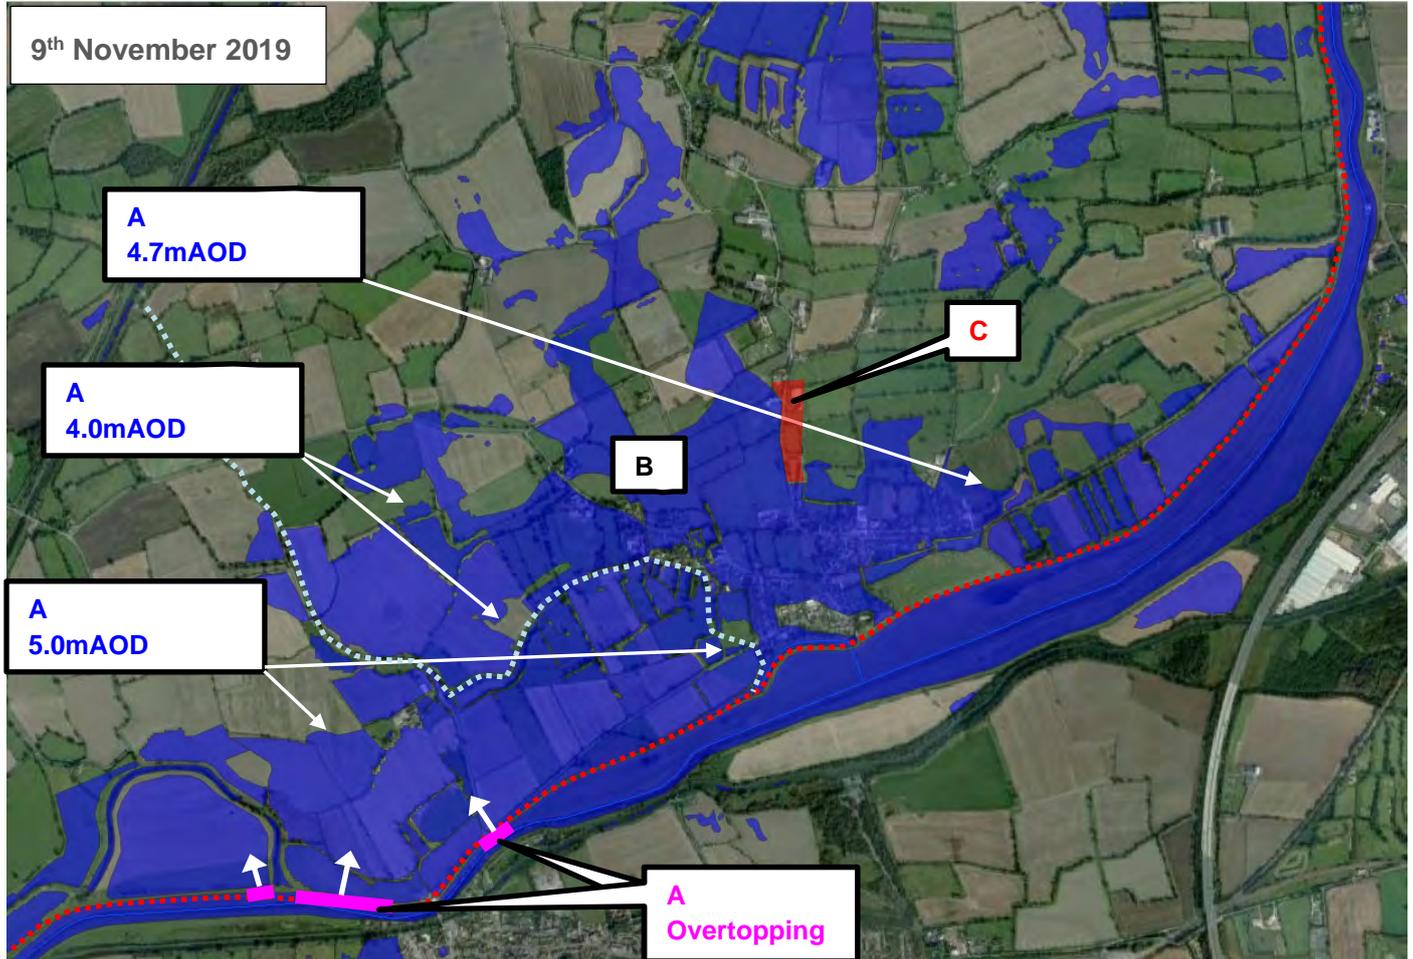
FIGURE 22: GOOGLE MAPS SCREENSHOT SHOWING FLOOD FLOW ROUTES AND EXTENT

5.5.2. Fishlake – 9th November

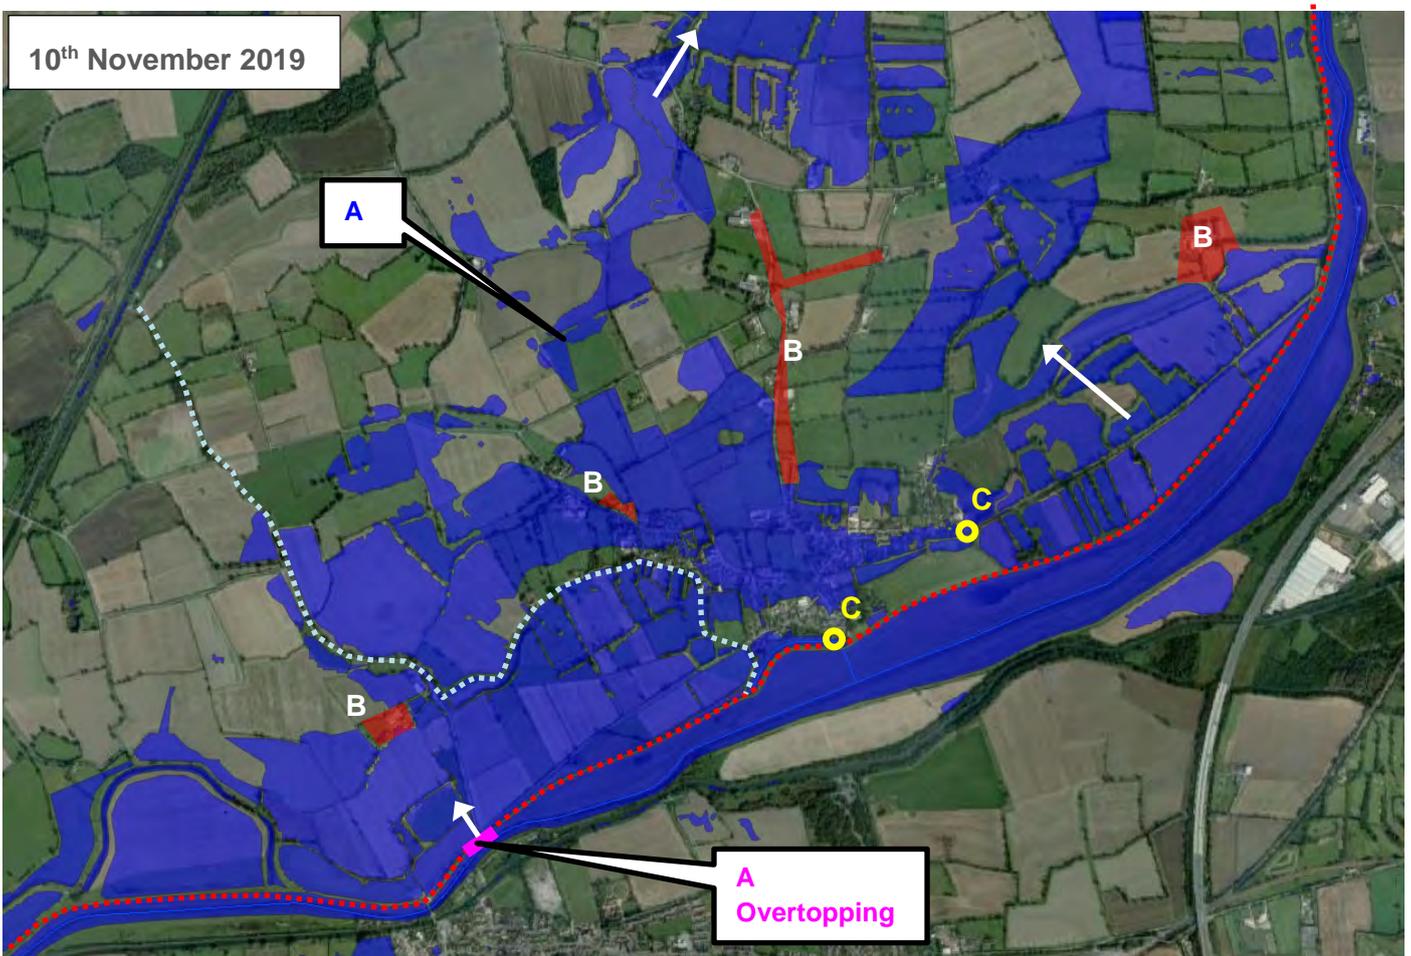
FIGURE 23: GOOGLE MAPS SCREENSHOT SHOWING FLOOD FLOW ROUTES AND EXTENT

5.5.3. Fishlake – 10th November

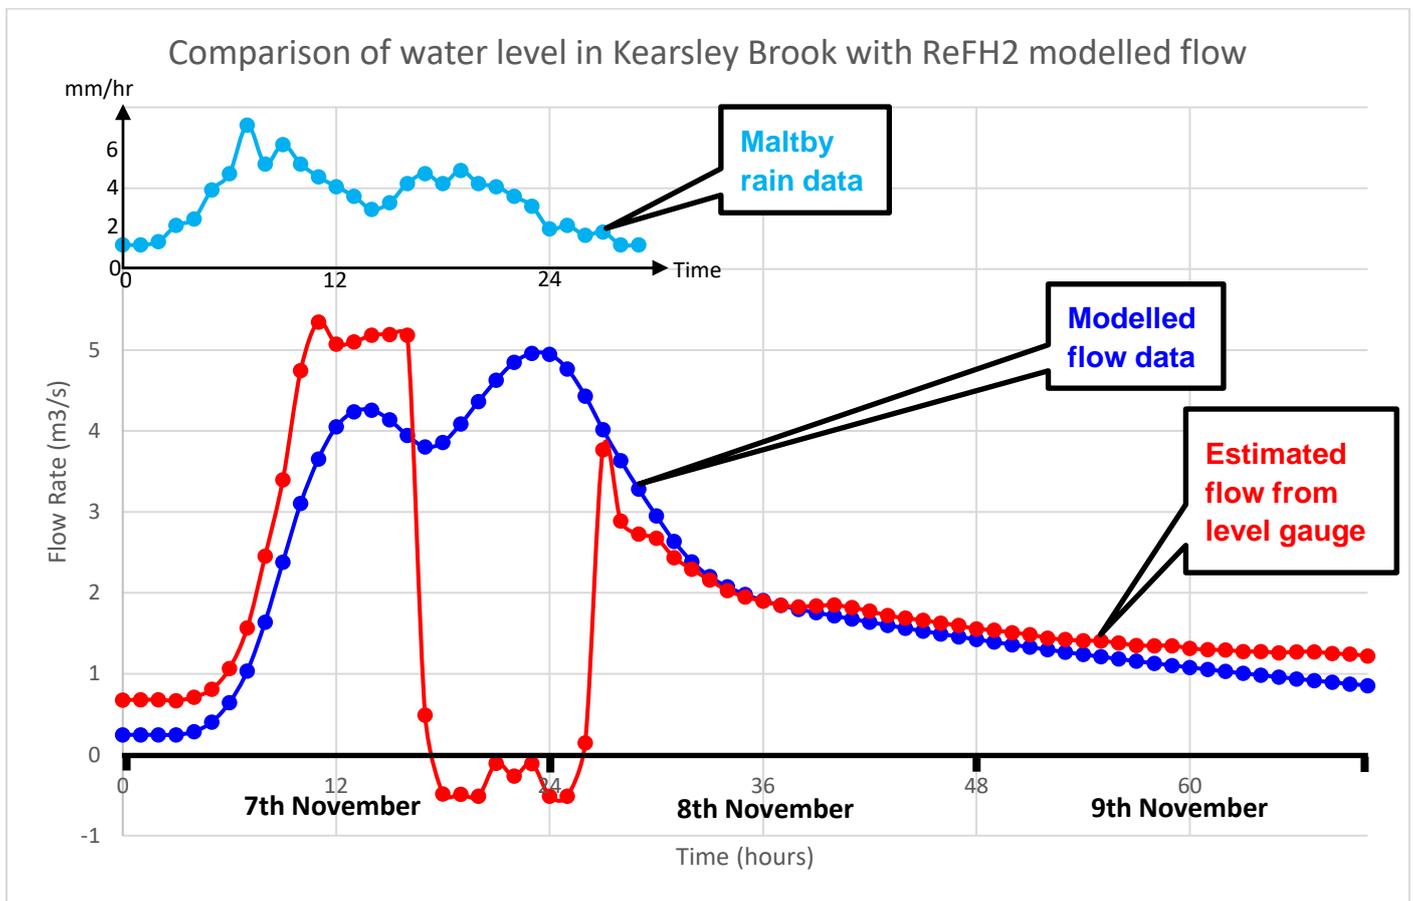
FIGURE 28: ESTIMATED FLOW FROM GAUGE DATA COMPARED WITH REFH2 MODELLED FLOW

Considering the above data, it seems likely that the Kearsley Brook flood event on the 7th November 2019 reached a peak flow of approximately 5m³/s which equates to a 2% - 1% AEP (50 year – 100 year return period).

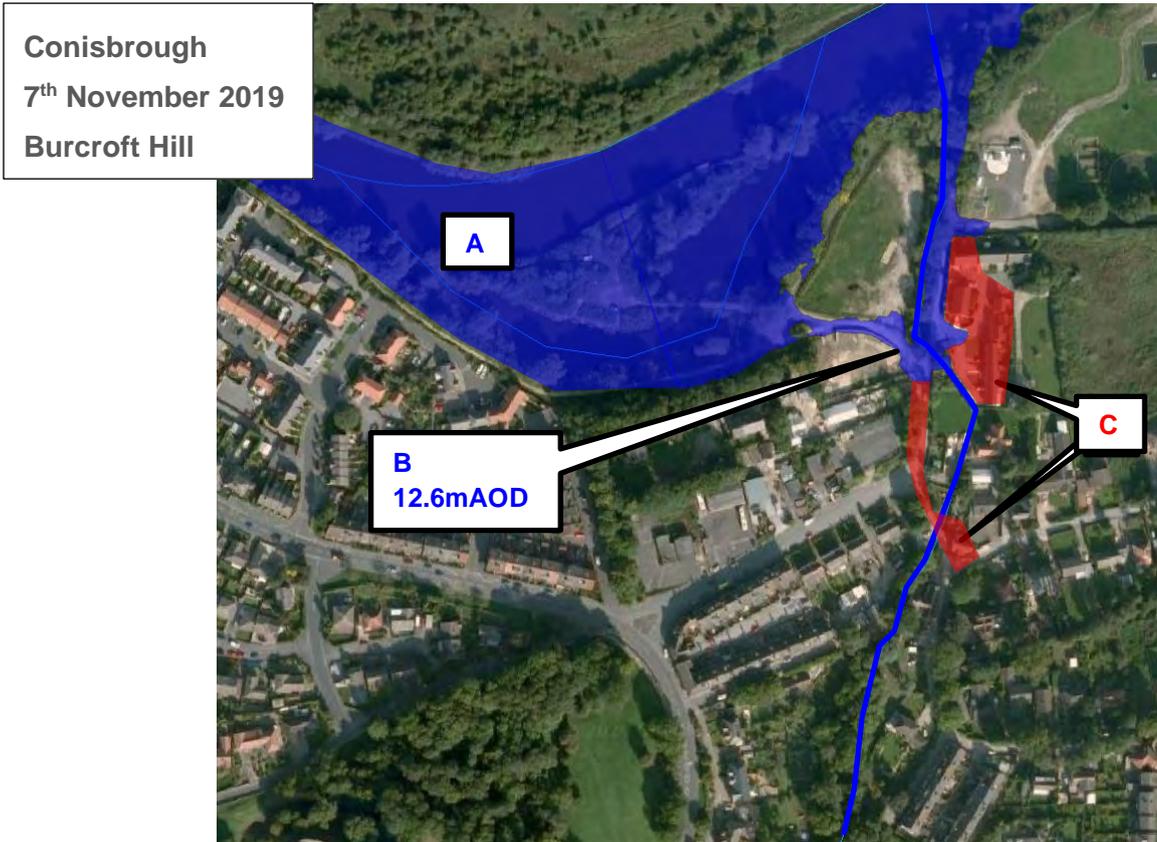
FIGURE 29: GOOGLE MAPS SCREENSHOT SHOWING FLOOD FLOW ROUTES AND EXTENT - NORTH

Within Conisbrough, 25 properties are recorded as having been flooded by Doncaster Council in November 2019.

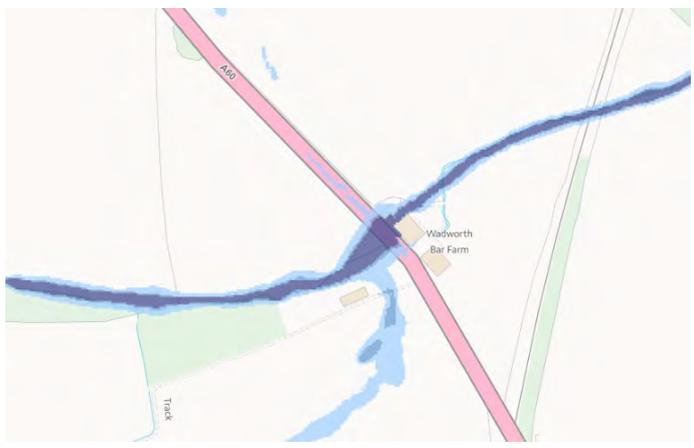
Groundwater Risk	Risk	
	<25% susceptible to groundwater flooding	
Sewer Flood Risk	At Risk	Details
	Unknown	It is unlikely that a rural location such as this would be served by sewers.
Conclusion	Flood risk is expected to be associated with heavy rain leading to high flows on the drain that crosses the A60, exceeding normal channel and culvert capacity.	
Recommendations	<ul style="list-style-type: none"> • Assess the flood mechanism in more detail. • Consider scope for increasing flow capacity and / or managing the flow path away from buildings.

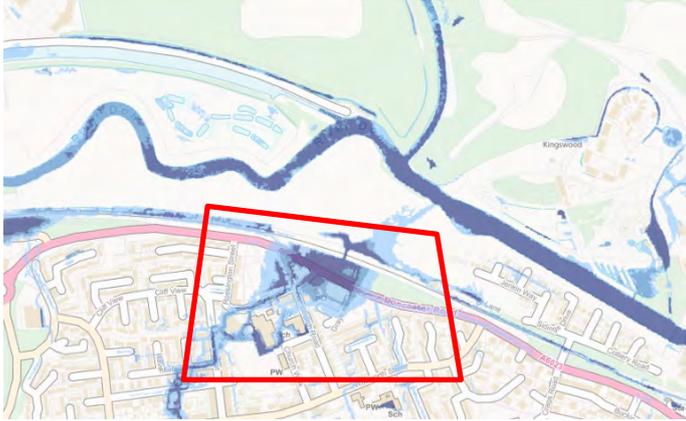
Groundwater Risk	Risk	
	<25% susceptible to groundwater flooding	
Sewer Flood Risk	At Risk	Details
	Unknown	This risk would be linked to surface water flooding and / or high water on the Don.
Conclusion	It is unlikely that flooding was direct from the River Don given that only one house within the area was affected. Surface water runoff from the south may have played a role coupled with a high water level on the Don limiting drainage capacity.	
Recommendations	<ul style="list-style-type: none"> Undertake a more detailed assessment of flood risk considering the natural surface water flow route from the south, drainage capacity and the influence of a high water level on the Don.

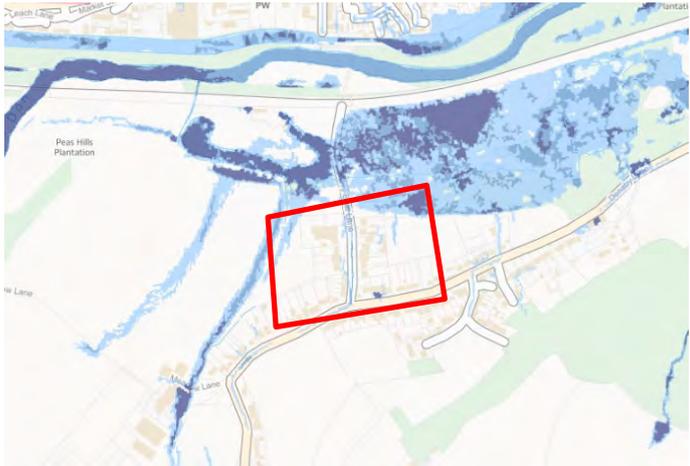
Groundwater Risk	Risk	
	25% – 50% susceptible to groundwater flooding	
Sewer Flood Risk	Risk	Details
	Unknown	This risk would be linked to surface water flooding.
Conclusion	It is reported by the Environment Agency that flooding was direct from the River Don even though only three properties within the area were affected. Surface water ponding and runoff from the south-west may have played a contributory role coupled with a high water level on the Don limiting drainage capacity.	
Recommendations	<ul style="list-style-type: none"> Undertake a more detailed assessment of flood risk considering the route of water from the Don along with the natural surface water ponding and flow route from the south-west, drainage capacity and the influence of a high water level on the Don.

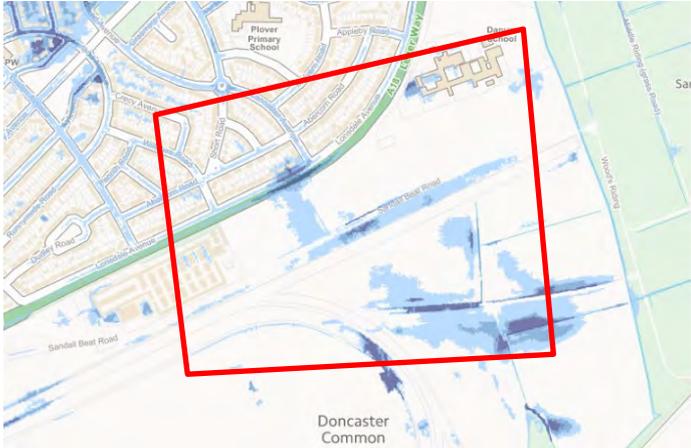
Groundwater Risk	Risk	
	0% - 25% susceptible to groundwater flooding	
Sewer Flood Risk	Risk	Details
	Yes	Yorkshire Water have identified some network issues in the area related to the pumping system, with investigation work planned.
Conclusion	The natural overland surface water flow route and interaction with buildings is likely to have played a role, coupled with a high water level on the downstream drains and local network.	
Recommendations	<ul style="list-style-type: none"> Undertake a more detailed assessment of flood risk considering the natural surface water flow route, drainage capacity and the influence of a high water level on the downstream drains.

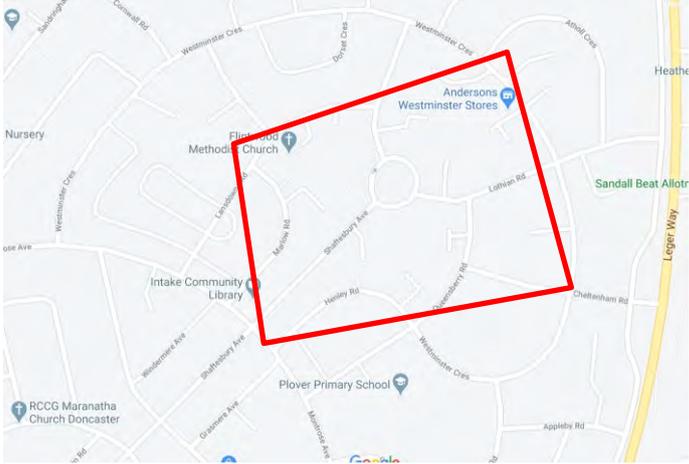
Number of properties affected	6			
Fluvial Risk	Source	Risk	Flood Zone	Benefits from Defences
	Main drain	Very Low	1	No
Tidal Risk	Risk		Details	
	No		N/A	
Surface Water Risk	Risk		Details	
	Low - High		There is a natural flow route crossing this area leading east into the drainage ditches in Woods Riding.

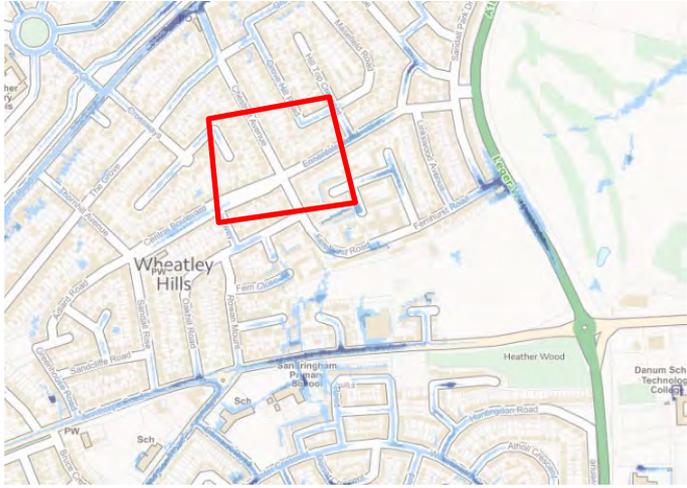
Environment Agency map of surface water flood risk

Tidal Risk	Risk		Details	
	No		N/A	
Surface Water Risk	Risk		Details	
	Low - High		A natural valley in the landscape associated with South Seats Drain

Groundwater Risk	Risk	
	0% - 25% susceptible to groundwater flooding	
Sewer Flood Risk	Risk	Details
	Unknown	This risk is expected to be linked to surface water flooding.
Conclusion	While there is no clear natural overland surface water flow route, it is likely the flood event is associated with local rainfall interacting with buildings, coupled with a high water level on the downstream drains and local network.	
Recommendations	<ul style="list-style-type: none"> Undertake a more detailed assessment of flood risk considering natural surface water flow routes, drainage capacity and the influence of a high water level on the downstream drains.

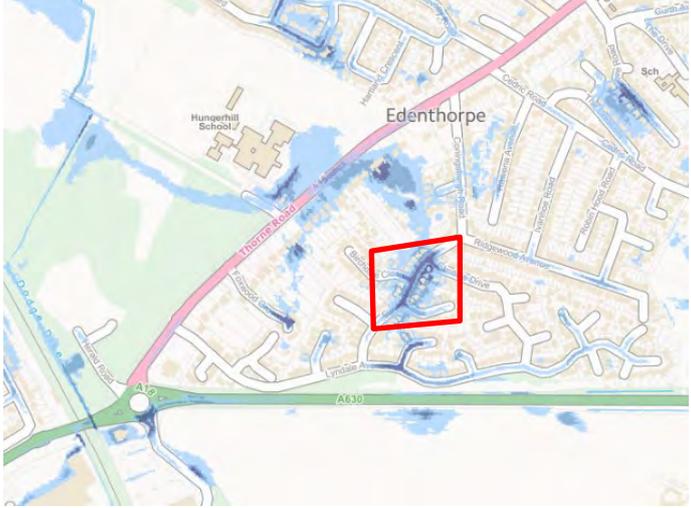
Risk	Details
	Low - High	There is a natural flow route crossing this area leading north-east into the Don.
	Environment Agency map of surface water flood risk

Groundwater Risk	Risk	
	Very low susceptibility	
Sewer Flood Risk	Risk	Details
	Unknown	This risk is expected to be linked to surface water flooding.
Conclusion	The natural overland surface water flow route and interaction with buildings is likely to have played a role, coupled with a high water level on the downstream drains and local network.	
Recommendations	<ul style="list-style-type: none"> Undertake a more detailed assessment of flood risk considering the natural surface water flow route, drainage capacity and the influence of a high water level on the downstream drains.

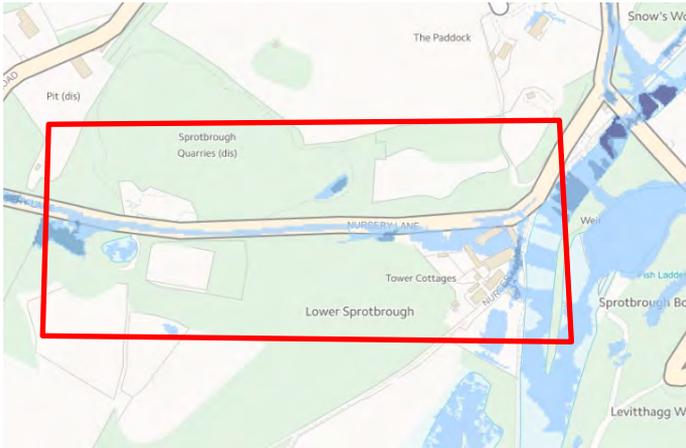
Risk	Details
	Low	There is a natural flow route crossing this area leading east into the Don.
	Environment Agency map of surface water flood risk

Groundwater Risk	Risk	
	<25% susceptible to groundwater flooding	
Sewer Flood Risk	Risk	Details
	Unknown	This risk is expected to be linked to surface water flooding.
Conclusion	It is reported by the Environment Agency that flooding resulted from the River Don however there may have been a contribution from the surface water flow route that flows to the Don.	
Recommendations	<ul style="list-style-type: none"> Undertake a more detailed assessment of flood risk considering the flow route from the Don along with the natural surface water flow route and interaction with River Don.

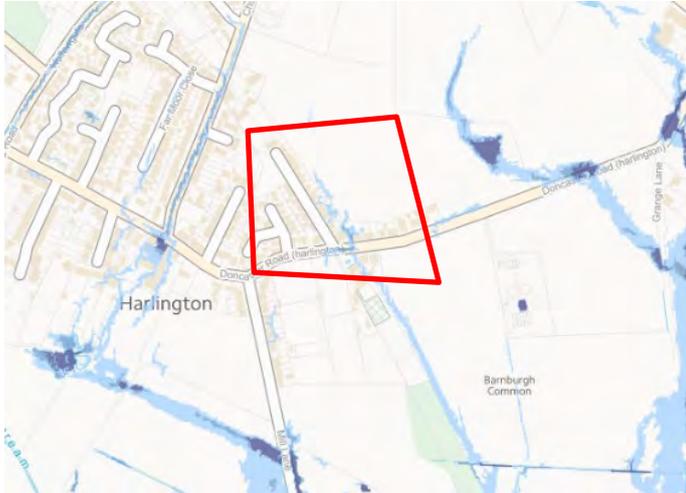
Environment Agency map of surface water flood risk

Number of properties affected	1			
Fluvial Risk	Source	Risk	Flood Zone	Benefits from Defences
	None	Very Low	1	No
Tidal Risk	Risk		Details	
	No		N/A	
Surface Water Risk	Risk		Details	
	Very Low		There is a natural flow route passing through the area heading to the south

Groundwater Risk	Risk	
	25% – 50% susceptible to groundwater flooding	
Sewer Flood Risk	Risk	Details
	Unknown	This risk is expected to be linked to surface water flooding.
Conclusion	The natural overland surface water flow route and interaction with buildings is likely to have played a role, coupled with a high water level on the downstream drains and local network.	
Recommendations	<ul style="list-style-type: none"> Undertake a more detailed assessment of flood risk considering the natural surface water flow route, drainage capacity and the influence of a high water level on the downstream drains.

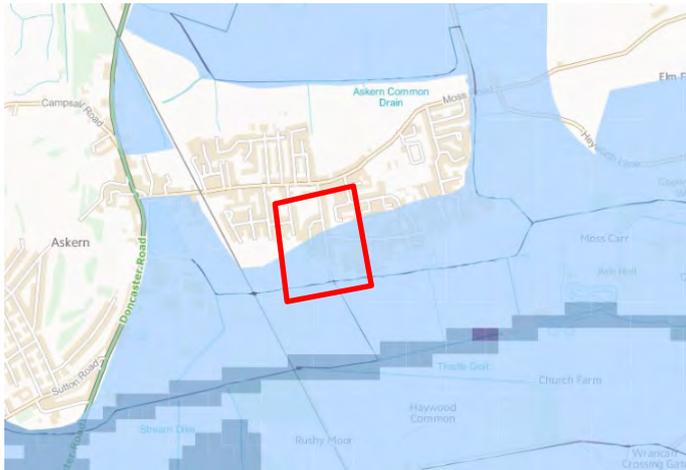
Surface Water Risk	Risk	Details
	Very Low	There is a natural flow route to the south of the affected property however no risk is indicated at the location of the house.
	Environment Agency map of surface water flood risk

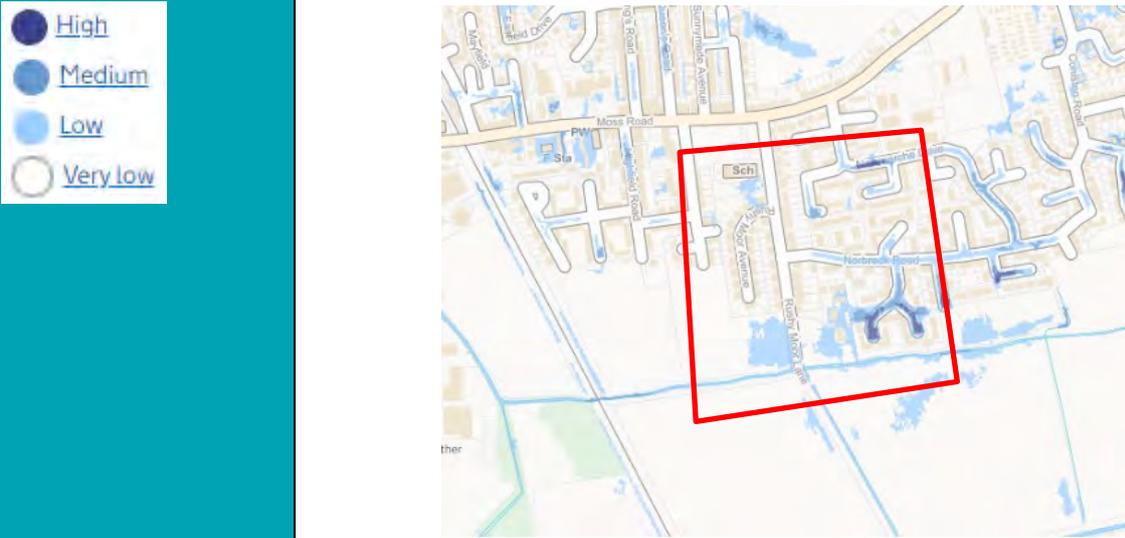
Groundwater Risk	Risk	
	<25% susceptible to groundwater flooding	
Sewer Flood Risk	Risk	Details
	Unknown	This risk is expected to be linked to surface water flooding.
Conclusion	It is unlikely that flooding was direct from the rivers given that only one property within the area was affected. Surface water ponding and runoff to the south may have played a role coupled with a high water level on the drains limiting drainage capacity.	
Recommendations	<ul style="list-style-type: none"> Undertake a more detailed assessment of flood risk considering the natural surface water ponding and flow routes, drainage capacity and the influence of a high water level on the drains.

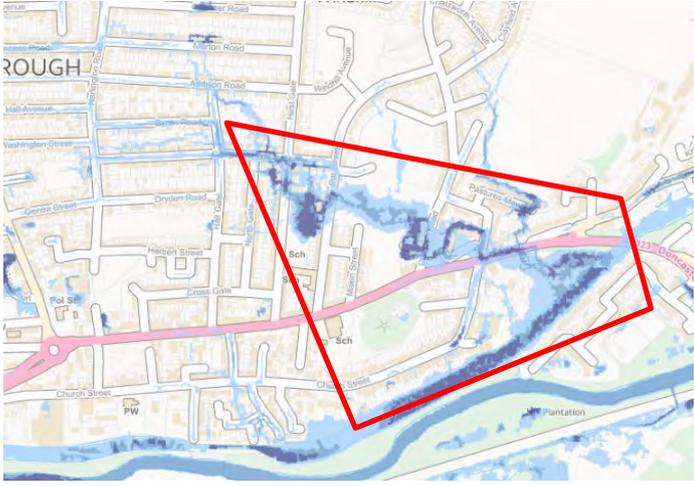
Environment Agency map of flood risk from rivers and sea

Number of properties affected	2			
Fluvial Risk	Source	Risk	Flood Zone	Benefits from Defences
	None	Very Low	1	No
Tidal Risk	Risk		Details	
	No		N/A	
Surface Water Risk	Risk		Details	
	Low - High		There is a natural surface water flow route that passes through this area discharging to the River Don.

Groundwater Risk	Risk	
	50% – 75% susceptible to groundwater flooding	
Sewer Flood Risk	Risk	Details
	Unknown	This risk is expected to be linked to surface water flooding.
Conclusion	The natural overland surface water flow route and interaction with buildings is likely to have played a role, coupled with a high water level on the downstream drains and local network.	
Recommendations	<ul style="list-style-type: none"> Undertake a more detailed assessment of flood risk considering the natural surface water flow route, drainage capacity and the influence of a high water level on the downstream drains.

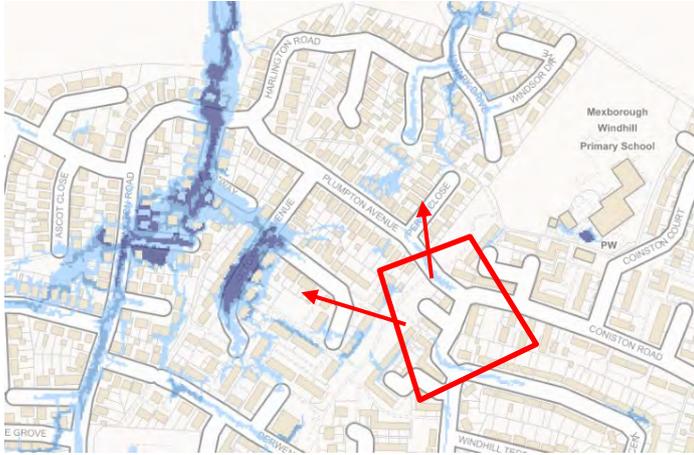
Environment Agency map of flood risk from rivers and sea

Groundwater Risk	Risk	
	Very low susceptibility to groundwater flooding	
Sewer Flood Risk	Risk	Details
	Unknown	This risk is expected to be linked to surface water flooding.
Conclusion	<p>Localised surface water ponding and feeding to the natural flow routes, along with interaction with buildings is likely to have played a role, coupled with a high water level on the downstream drains and local network.</p>	
Recommendations	<ul style="list-style-type: none"> Undertake a more detailed assessment of flood risk considering the natural surface water flow routes, drainage capacity and the influence of a high water level on the downstream drains.

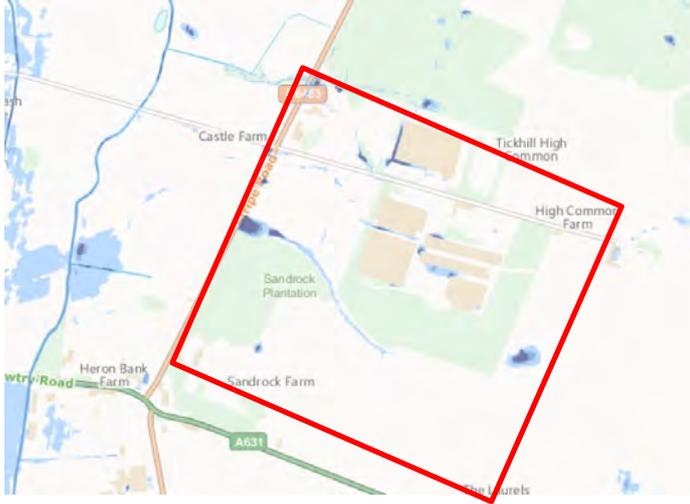
Environment Agency map of surface water flood risk

Surface Water Risk	Risk	Risk
	Very Low	The risk identified on the Environment Agency's surface water flood map is directly associated with the Don and Dearne.
Groundwater Risk	Risk	
	>= 25% <50% susceptible to groundwater flooding	
Sewer Flood Risk	At Risk	Details
	Unknown	This risk is expected to be linked to surface water flooding.
Conclusion	It is expected that the River Don / Dearne confluence is the most likely source of flood water although localised surface water flooding may have occurred given that drainage would have been limited by the high river levels.	
Recommendations	<ul style="list-style-type: none"> Undertake a more detailed assessment of flood risk considering the River Don and River Dearne along with complex interactions linked to river structures, downstream drainage and local flow routes.

Groundwater Risk	Risk	
	>= 25% <50% susceptible to groundwater flooding	
Sewer Flood Risk	Risk	Details
	Unknown	This risk is expected to be linked to surface water flooding.
Conclusion	It is expected that flooding resulted from localised surface water ponding and the surface water flow route which flows from the east to the west to the River Torne.	
Recommendations	<ul style="list-style-type: none"> Undertake a more detailed assessment of flood risk considering the natural surface water flow route and drainage capacity.

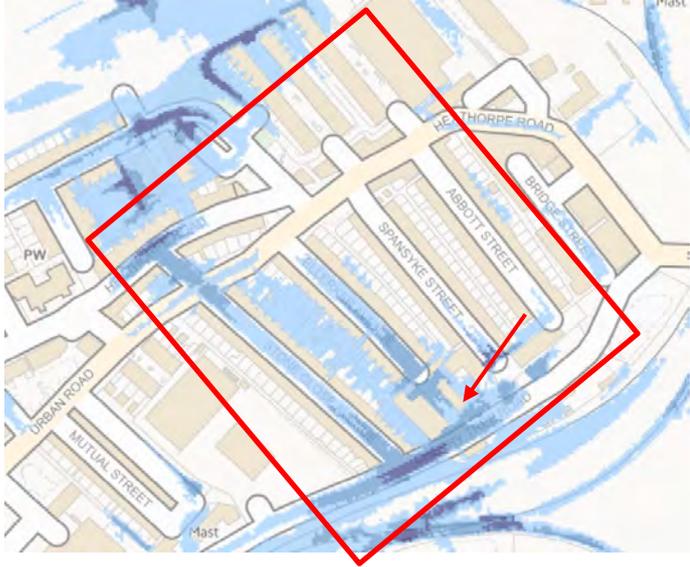
Environment Agency map of surface water flood risk

Groundwater Risk	Risk	
	<25% susceptible to groundwater flooding	
Sewer Flood Risk	Risk	Details
	Unknown	This risk is expected to be linked to surface water flooding.
Conclusion	The natural overland surface water flow route and interaction with buildings is likely to have played a role, coupled with a high water level on the downstream drains and local network.	
Recommendations	<ul style="list-style-type: none"> Undertake a more detailed assessment of flood risk considering the natural surface water flow route, drainage capacity and the influence of a high water level on the downstream drains.

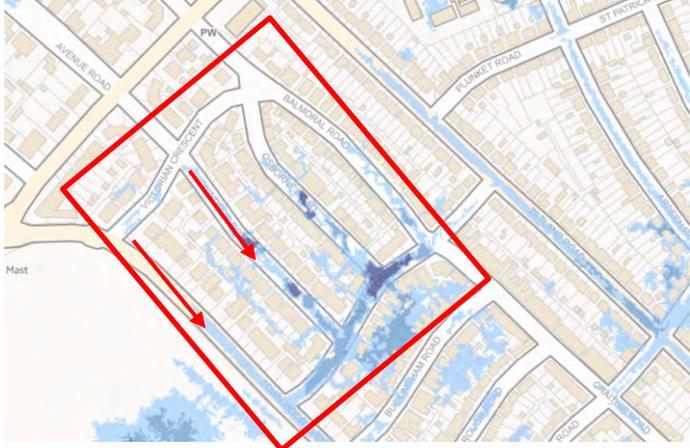
Environment Agency map of surface water flood risk

Community - Wheatley				
Location	Victorian Crescent, Towns Field			
Overview Location Map (Google Maps)				
Number of properties affected	1			
Fluvial Risk	Source	Risk	Flood Zone	Benefits from Defences
	None	Very Low	1	No
Tidal Risk	Risk		Details	
	No		N/A	
Surface Water Risk	Risk		Details	
	Very Low - Low		There is a natural flow route from Victorian Crescent leading to low-lying land to the south.

Groundwater Risk	Risk	
	>= 25% <50% susceptible to groundwater flooding	
Sewer Flood Risk	Risk	Details
	Unknown	This risk is expected to be linked to surface water flooding.
Conclusion	Localised surface water ponding, associated with the natural flow route, interacting with buildings is likely to have played a role. This would have been coupled with a high water level on the downstream drains and local network.	
Recommendations	<ul style="list-style-type: none"> Undertake a more detailed assessment of flood risk considering the natural surface water flow route, drainage capacity and the influence of a high water level on the downstream drains.

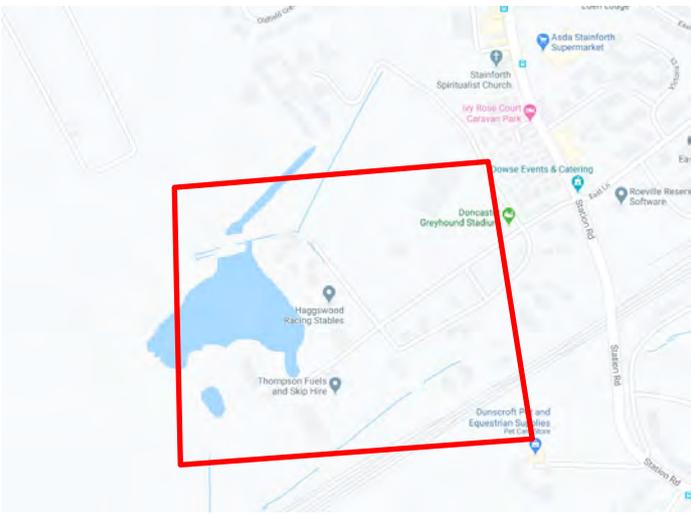
Number of properties affected	2			
Fluvial Risk	Source	Risk	Flood Zone	Benefits from Defences
	River Don	Medium	3	No
	Environment Agency map of flood risk from rivers and sea

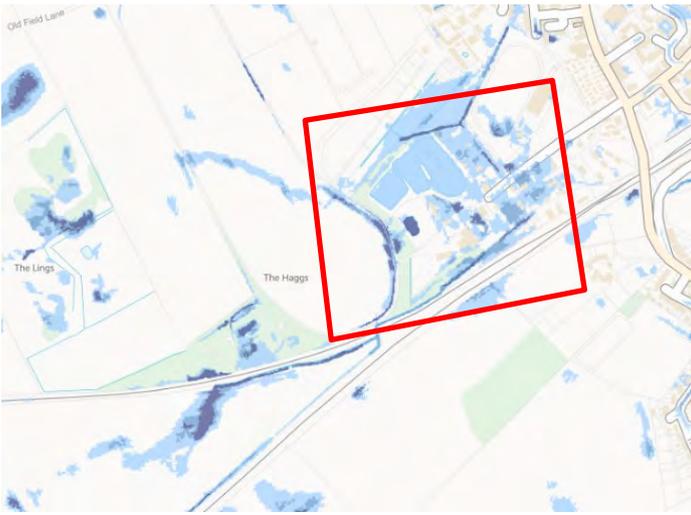
Surface Water Risk	Risk	Details
	Low - Medium	The affected area sits within naturally low-lying land with a surface water flow route feeding water from the west.
	Environment Agency map of surface water flood risk

Groundwater Risk	Risk	
	>= 75% susceptibility to groundwater flooding	
Sewer Flood Risk	Risk	Details
	Unknown	This risk is expected to be linked to surface water flooding.
Conclusion	It is unlikely that flooding was direct from the River Don given that only two properties in the area were affected. Localised surface water ponding within the low-lying land coupled with the natural flow route is likely to have played a role. This would have been compounded by a high water level on the downstream drains and local network.	
Recommendations	<ul style="list-style-type: none"> Undertake a more detailed assessment of flood risk considering the natural surface water ponding / flow route, drainage capacity and the influence of a high water level on the downstream drains.
