Conisbrough Conservation Area

Review

March 2015

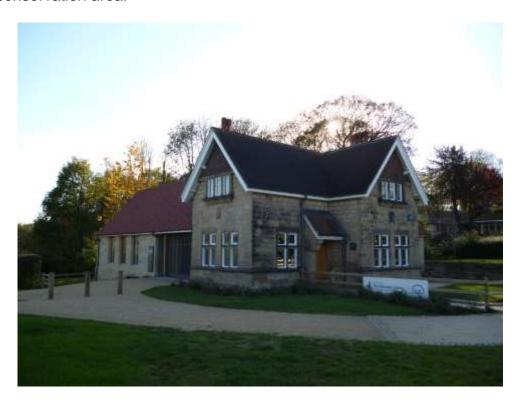
Conisbrough Castle Visitor Centre, Castle Hill

A new visitor centre has replaced the previously unpopular visitor centre. The latter, whilst previously neutral in its contribution to the conservation area, was seen as having a negative impact on the Grade I Listed and Scheduled Castle. The new centre retains and extends the previous lodge, which as well as being in the curtilage of the castle was also considered in the original appraisal to be a key building in the conservation area and therefore has secured its future and the finished centre complements the castle and the conservation area.

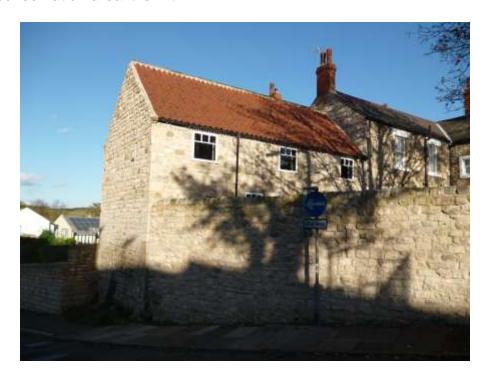
Castle House, Castle Hill

The original barn of the building had to be demolished due to its structural condition, exacerbated by the earthquake of 2008. Care was taken to ensure the rebuilding had as much of the character and general appearance of the previous barn as well as reusing the original stone. The adjoining walls were

also rebuilt and the overall appearance complements the listed building and the conservation area it is within.

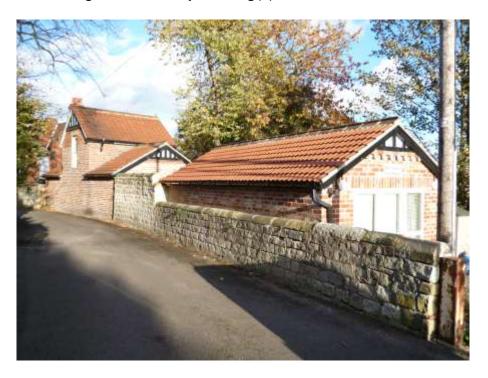
Former Coach House, Castle Terrace

At the time of the original appraisal, the condition of this property was causing concern. It has since been extended and converted into a family home but retains the feeling of an auxiliary building(s) to 'The Terrace'.

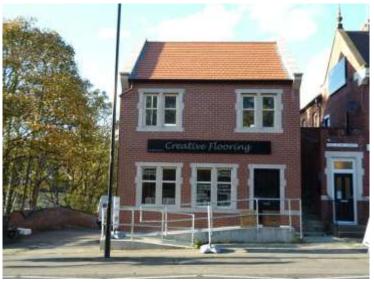
Adj. Star Public House, Doncaster Road

This development echoes that of The Star and its bricks attempt to copy the appearance of Conisbrough bricks. It also has natural red clay plain tiles and sliding sash windows and is considered to make a positive contribution to the area. The building however is spoilt by a very municipal looking ramp and its replacement with something of a more appropriate design would be strongly encouraged.

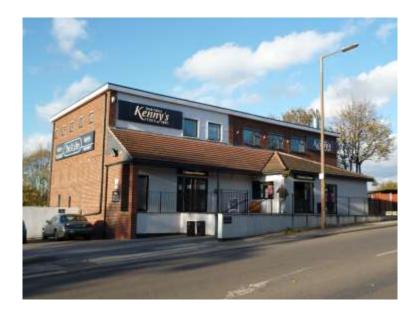
Kenny's Fish and Chip Restaurant, Doncaster Road

This was previously 'The Venue' nightclub which as well as having a negative impact on the conservation area due to its bland modern architecture had been vacant for a considerable time. Although the building is back in use its appearance is virtually the same and would still be considered to have a negative impact on the conservation area.

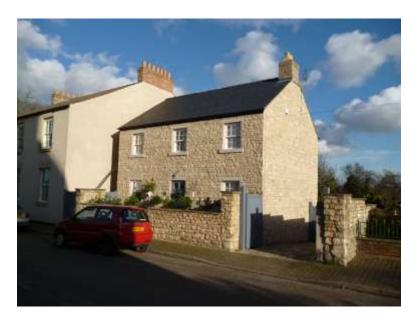
Adjoining Lowfield House, High Street

On the site of long demolished cottages a new house has been built. Care has been taken to ensure that the building fits in with its surroundings. It is in limestone rubble brought to course with slate roof and sash windows and makes a very positive contribution to the area and thought to be admirable.

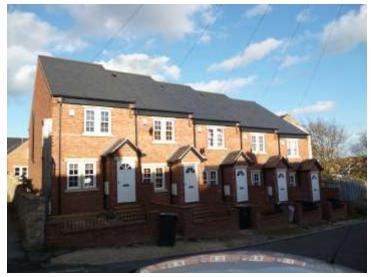
March Street

A row of five town houses has been built on previously vacant land and their design is in line with guideline on appropriate developments being red brick, slate roof and vertically sliding windows, although the fanlight within the doors detract. Overall they are considered to make a positive contribution to the area.

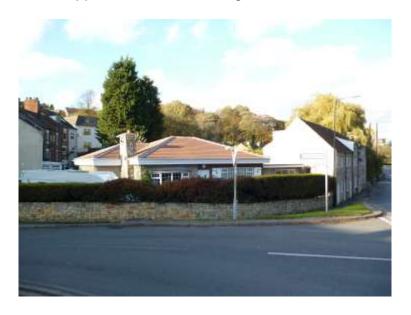
1 Low Road

This building was considered to make a negative contribution to the conservation area. With the proposed erection of a new roof there was potential for this building to further detract by the use of modern concrete tiles. However, clay tiles was insisted upon and help tie this building more in with the traditional character of the area. This building is now considered to have a much more neutral appearance to it, although the white fascia boards detract.

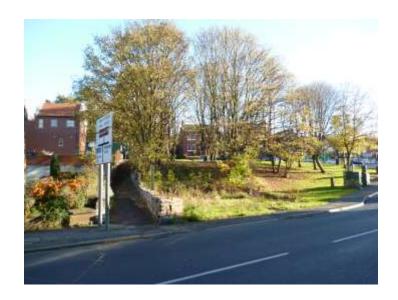
Old Workshop, Low Road

The old workshop which in the original appraisal was considered to make a negative contribution has now been demolished. Planning permission has been granted for two town houses which use the adjoining terraced properties as their inspiration. Details and materials are proposed which are in keeping with the use of smooth red engineering bricks, sash windows with sandstone dressings and slate roofs.

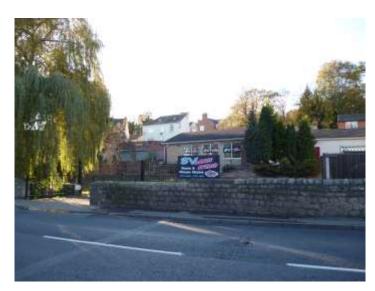
Dance Studio (former Printers), Low Road

Previously a printers, this building is now a dance school. The conifers along the front boundary have been removed which beforehand gave a suburban feel to the area. This has exposed the modern building behind which is not of any historic merit but as it is well set back it is still considered to be neutral.

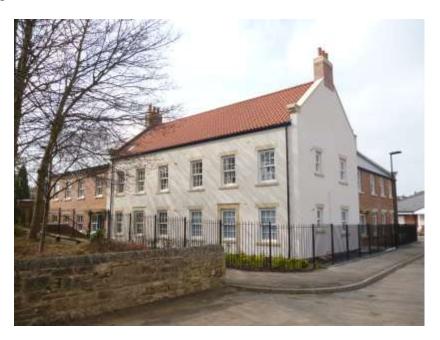
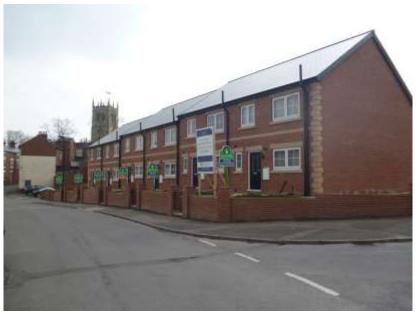
Well Gate

Whilst not currently in the conservation area there have been two developments on and around Well Gate. The fact that their sites were recommended to be included in the conservation area was a material consideration in their planning applications. Unfortunately vents, meter boxes and soilstacks, especially the latter, detract from the one fronting Well Gate. However, both are considered to make a positive contribution to the conservation area and would still justify the inclusion of them and the adjoining areas into the conservation area

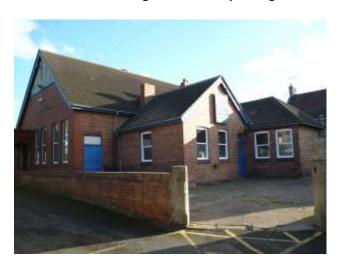
Church Hall, Church Street

The building lies close to the Grade I listed Church of St. Peter and care was taken to ensure that the design, although in uPVC, was sympathetic to the historic character of the church hall and the adjoining conservation. In particular the windows to Church Street replaced casements with sliding sashes which enhances the building and the adjoining conservation area.

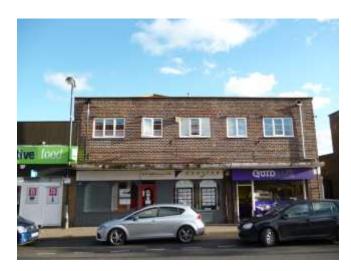
32 - 40 Church Street

The first floor of this building was converted into flats including the changing of its windows. The new windows have been designed to reflect the 1950s style of the building and whilst not a vernacular building this has been beneficial to the appearance of the building and the conservation area. Although this has improved the appearance of the building, the canopies and shopfronts still detract and it would still be considered neutral.

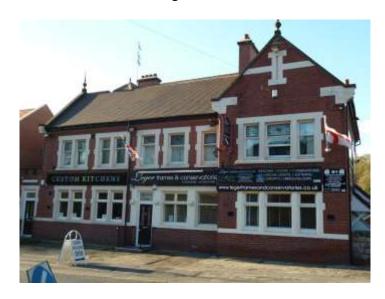
Former Star Public House, Doncaster Road

With the conversion of the building to flats, the rear windows of the property were replaced in uPVC. This was considered to be acceptable as it was not the main façade and as this elevation is set back front the road. The frontage windows however have been retained and refurbished. Improvements to the signage would however be encouraged.

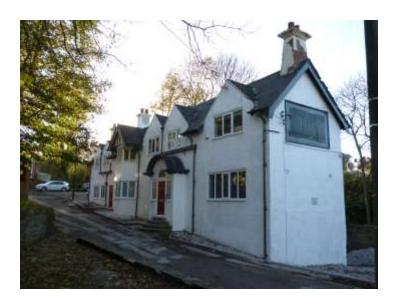
'The Castle' Public House, Minneymoor Hill

At the time of the original appraisal the condition of this building was of concern. It was considered to be a potential bookend to the conservation area and was therefore recommended to be included within the conservation area. The building has since been converted to office use and whilst it now has uPVC windows its future has been secured and it would still make a positive contribution if it were to be added to conservation area.

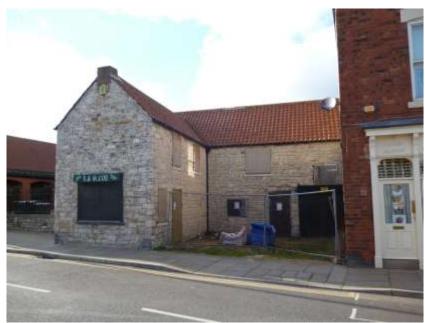
39 Church Street

Works have continued on 39 Church Street, which now appears to be coming to completion. However there are still concerns over The Priory, Former Police Station and 12 High Street. The council will continue to work with owners to get empty buildings back in use.

As discussed earlier the building has had works occurring on it over a number of years but which seems to be nearing completion. The removal of the external roller shutter to the front window and the replacement of windows more sympathetic to the character of the area such as vertically sliding sashes would be welcome.

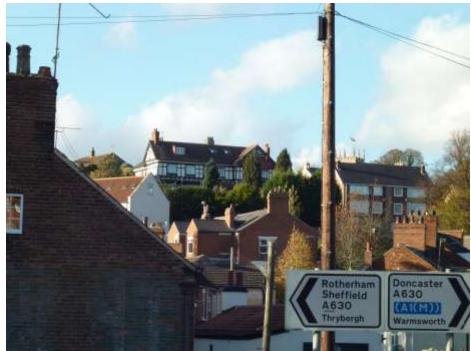
A proposal to build a bungalow in the rear garden was refused planning permission and was also upheld at appeal. The Planning Inspector referred to the Conservation Area Appraisal in his decision and noted that the building was designated as a key unlisted building, and that the proposed development would rob Ivanhoe Lodge of its setting, make it appear unacceptably cramped and undermine its status in the conservation area. The loss of green space, removal of stone boundary walls and the design of the proposed new dwelling were also additional reasons that the development was not considered acceptable.

Ivanhoe Lodge is the prominent half-timbered building in the centre background of this photograph and the refused development land is the green space in front of this

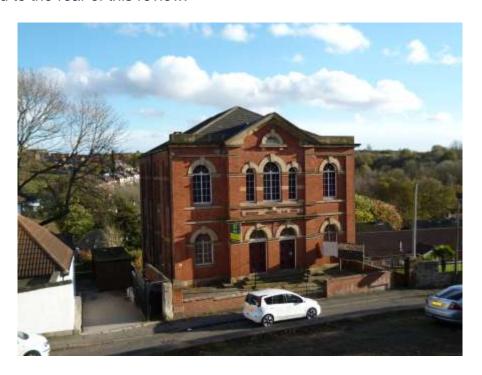
The Chapel on Chapel Lane, which was proposed to be included into the conservation area in the appraisal of 2010 as it was considered to add to the character and appearance of the conservation area and be a key unlisted building has just (19/03/15) at the time of writing this review been listed Grade II

This is a good example of a Victorian Chapel built in 1876. It appears to be two storeys from the front but as the ground slopes down away there is a basement making it three storeys from sides and rear. It is red brick with concrete roof tiles, rather than presumably originally a Welsh slate roof. The windows are round headed and the frontage has stone dressings with a pediment, whilst side and rear have contrast banding in yellow brick. Windows are predominantly timber which are small paned on the frontage. The chapel is now vacant but does have planning permission for conversion to a single dwelling. As the building is now listed, listed building consent will also now be required for works that affect its special interest. The full list description is added to the rear of this review.

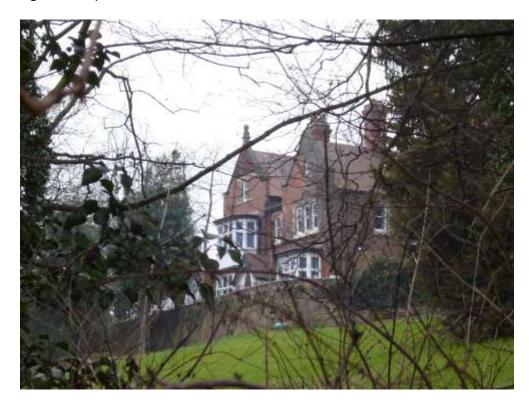
The Terrace, Castle Avenue

This large Victorian house is now a conference facility. It started life as the Denaby Pits Manager's Home, it then became a school before turning into its current use. It is prominent in the townscape. It is two storeys with attic storey in red brick with stone dressings. It is roofed in small red plain tiles, with decorative gables. Windows are in timber with casements to bay windows sliding sashes to other windows. Its grounds are well treed that add to its setting and as part of ambience of the area around castle.

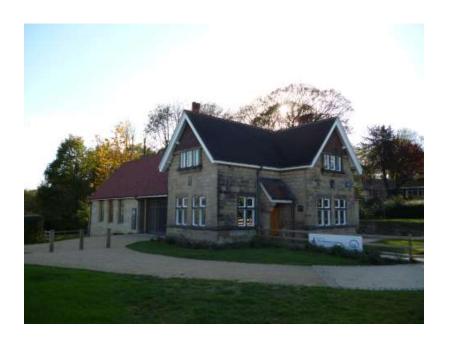
Castle Lodge, Castle Hill

Castle Lodge was built as the custodian's house in 1887, and was paid for by Lord Conyers. It would be considered to lie within the curtilage of the castle and therefore be covered by listed building legislation, but would also be considered a key building in its own right. The Lodge is in sandstone with clay red plain tiles and incorporates the castle's DeWarren family coat of arms into its masonry. It has timber windows. The lodge has recently been extended to form a new visitor centre replacing the previously unpopular visitor centre and has secured its future and the finished centre complements the castle and the conservation area.

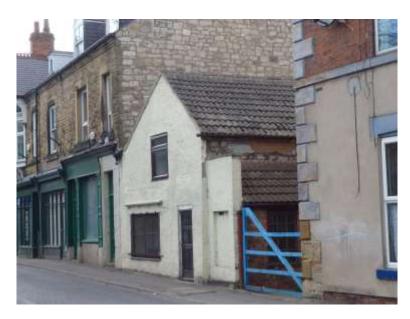
7 Church Street

This building appears to be from the early 18th century due to its form, which is relatively simple and its size being fairly small scale. It is rendered and unfortunately it does have an inappropriate modern concrete tiled roof and replacement windows. These detract and their replacement with ones constructed with more sympathetic materials and detailing would be extremely welcome.

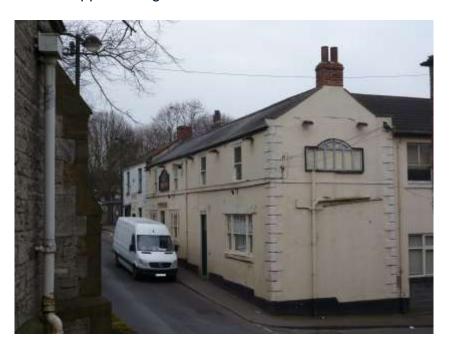
The Fox PH, Church Street

Former public house now vacant. On prominent corner opposite Grade I Church of St. Peter. Two storeys of simple form rendered with quoins, Welsh slate to front slope but unfortunately roofed in concrete tile to side and behind. The building benefited from grant assistance with refurbishment and redecoration, including the installation of vertically sliding sash windows on its frontage but now appears neglected.

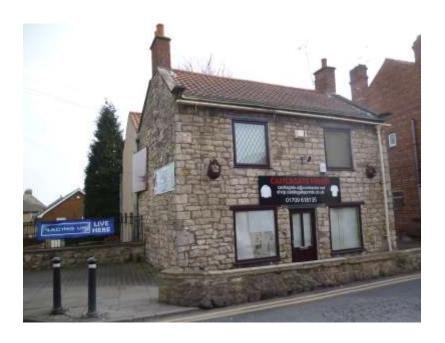
20 Church Street

This building is considered to be important as it one of few buildings that are constructed in limestone rubble brought to course which is the traditional material of the area. Its double piled form and stonework would seem to date it as 18th century although further assessment of its history and fabric may help to give a more accurate date. It is set lower than the street outside, as ground levels seem to have been raised since it was originally built. It is two storied with central doorway to ground floor with windows either side, with first floor windows directly above the ground floor windows – windows and doors are modern and detract as does the signage – replacement with more sympathetic elements would be welcomed and should be based on old photographs of the building. Roof is natural red clay pantiles with stone eaves course with stone copings to gables with kneelers and chimneystacks to the ends of the front ridge, all these features are in keeping with its architecture and should be retained.

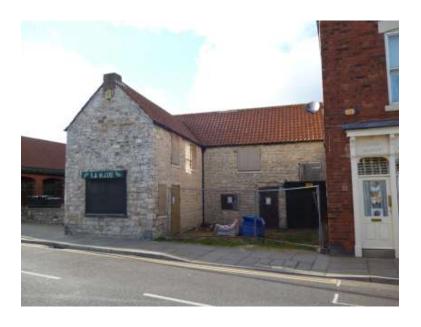
39 Church Street

Again this building is considered to be important as it one of few buildings that are constructed in limestone rubble brought to course which is the traditional material of the area. Its form is quite simple being L-shaped with a gable to the roadside and the return set back to create a small front yard to the building which is currently unenclosed to the road. Its form and its stonework would seem to date it as late 17th century/early 18th century although further assessment of its history and fabric may help to give a more accurate date, although some features have been removed such as the central chimney stack. Evidence on the front gable seem to show that it was originally lower and has subsequently been heightened.

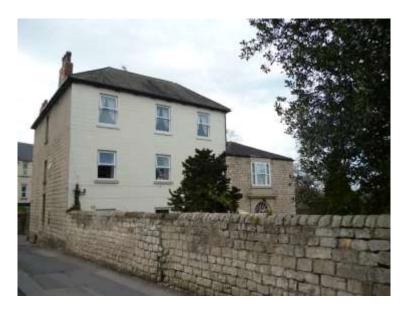
The Dale, Dale Road (not currently in the conservation area but proposed to be included)

This building and its grounds lie currently adjacent to the conservation area, and the building and its land are seen very much as a continuation of the character of the adjoining part of the conservation area. The building appears to date from the Georgian period with Victorian additions and is considered to be a key unlisted building due to its architectural and historic interest. The earlier building is a good example of a two storey stone building and with the later three storey extension retains many original features, such as natural slate roofs. Unfortunately the timber vertically sliding sash windows have been recently replace with crude uPVC and their restoration should be sought. The Victorian extension is also a landmark building on Dale Road. The grounds are well treed.

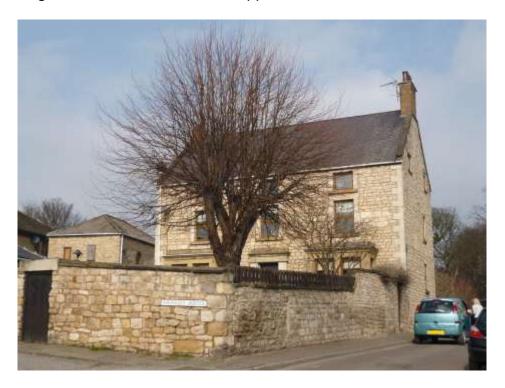
5 High Street

This is a large house which due to its size is prominent in the street. Again this building is considered to be important as it one of few buildings that are constructed in limestone rubble brought to course which is the traditional material of the area. It is three storied and three bayed, and the limestone is complemented by the natural Welsh slate roof with chimney stacks at either end. The building has grandeur to it with its ground floor bay window and stone door surround and stone quoins to the corners. Regrettably the original timber vertically sliding sash windows have been replaced as brown uPVC top-hung casements. Tall stone walls wall form its boundary with neighbouring streets, with monolithic stone gate piers to main vehicular entrance. In the grounds is an interesting outbuilding – possibly a coach house, again in limestone but with a hipped roof and some circular windows.

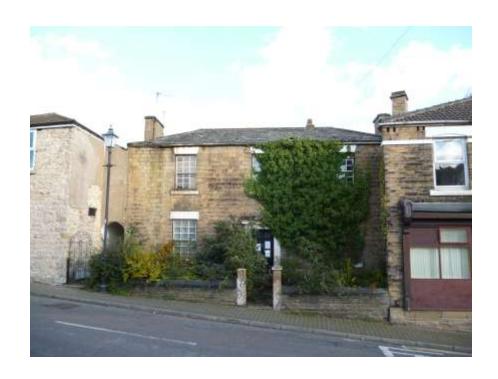
12 High Street

This property is again one of the few remaining buildings constructed in stone, although it is not local limestone rubble but sandstone in large shaped blocks, with hipped roof in Welsh slates. It is two storeys and three bays set back from the road that adds to its former grandeur, although noted above its current condition is of deep concern. Central six panelled door with stone surround and small paned vertically sliding sash windows either side with same above all on first floor.

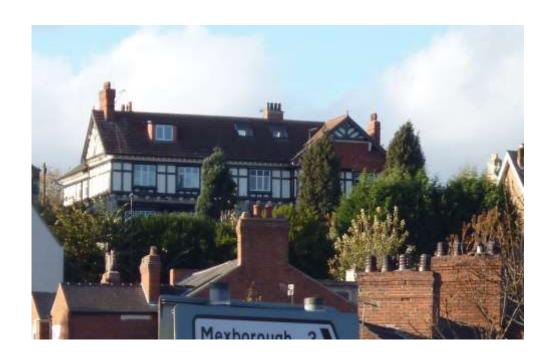
Ivanhoe Lodge, High Street

Large late Victorian/early Edwardian property which was the home of George Kilner of the 'Kilner jar' fame, whose family came from Thornhill Lees to set up their factory in Conisbrough in 1863. It is prestigious and appropriately set in large grounds. It is of two storeys, with sandstone ground floor and half-timbering above. Roofs towards High Street are in slate although that facing the valley of Kearsley Brook is unfortunately in concrete.

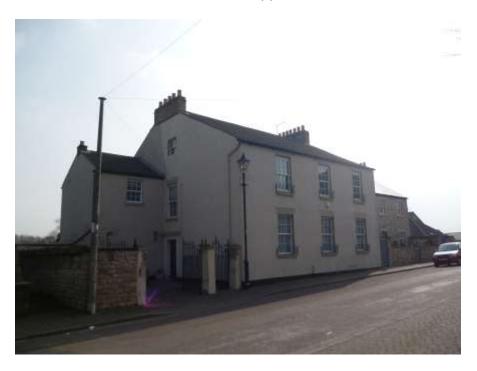
Lowfield House, High Street

Large dwelling that is prominent in street. Wide spanned, two storeys and three bays with balanced frontage. Vertically sliding sash windows, although in uPVC rather than timber as would be traditional, with voussoirs and sills. Its rendered finish conceals previous alterations including the removal of an inserted shopfront and results in its current very pleasing appearance. Roof is quite shallow, so that its concrete tiled roof is fortunately not that apparent but would originally have been Welsh slate, with wide chimneystacks either end of ridge. Small offshoot to left hand side set back beyond entrance door with stone surround to side return with sash window above detailed like those to front. Gate piers with shaped caps and decorative gates giving vehicular and pedestrian entrance to forecourt area on approach to left-hand entrance

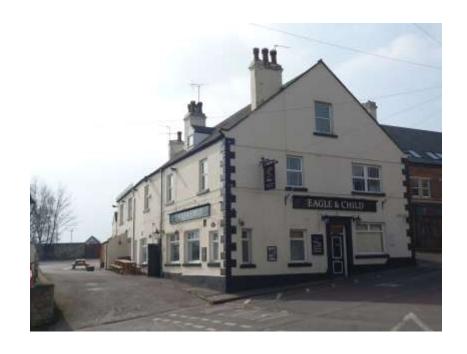
Eagle and Child PH, West Street

A prominent building on the corner of West Street and High Street. Two storied, rendered with stone painted quoins and Welsh slate roof. The building has been redecorated since the original appraisal — most windows unfortunately have been replaced with ones with cruder detailing than originally as seen in old photographs of the building.
